6th International Conference on Industrial, Mechanical, Electrical and Chemical Engineering  
(ICIMECE 2020)

# Fracture and Damage to the Material accounting for Transportation Crash and Accident

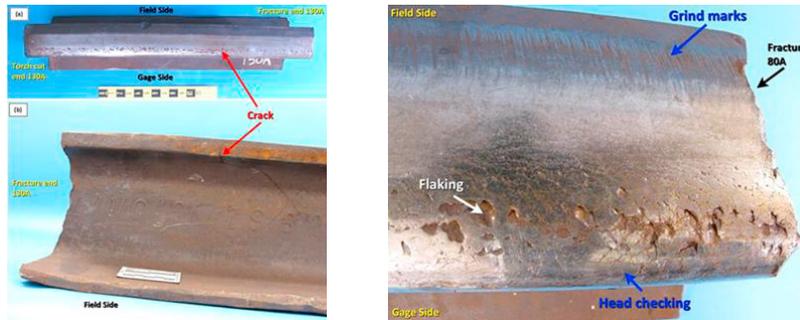
Fig. 2. Fracture on eastbound Norfolk Southern railroad tracks on July 11, 2012 (Zakar and Mueller 2016).

In work by Jun et al. (2016) investigated that fracture and fatigue crack growth on a weld-repaired railway rail due to the direction of cracks was perpendicular to the course of the applied force. When a train set passes over the crack, tensile residual stress opens the crack and accelerates the crack growth. In contrast, it closes the crack and decelerates the crack growth by compressive residual stress. Hence in the paper by Jun et al. (2016), to reduce the unanticipated initiation and propagation of the crack, it was essential to change the tensile stress to compressive stress at the railhead. To prevent the crack from growing, especially on the rail surface, the transition from tensile to compressive stress was beneficial due to contact stress. Some fractures that occurred on the eastbound Norfolk Southern railroad tracks in the city of Columbus, Ohio, on July 11, 2012, are shown in Fig. 2. Further, to identify and remove internal defects before reaching critical size, inspection, and maintenance programs based on damage-tolerance programs must be developed (Zakar and Mueller, 2016).

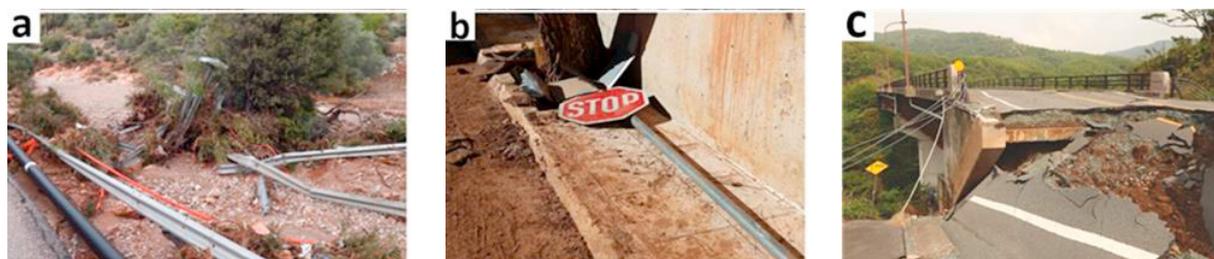
Fig. 4. Damage on infrastructure due to floods and earthquakes, including (a) damaged road fences, (b) broken road signs (Diakakis et al. 2020), and (c) damage to the Tawarayama bridge (Aye et al. 2018).

An investigation by Syromyatnikova et al. (2019) on the gas pipeline in the Republic of Sakha (Yakutia) showed that destruction could occur due to conditions that were difficult to detect the current state like the presence of corrosion catalysts over a long period. Earthquakes can also cause damage such as a bridge in Tawarayama, Kumamoto, Japan in 2016, as shown in Fig. 4c. An investigation by Aye et al. (2018) conducted that this damage was caused by a massive ground motion that led to the movement of the entire bridge. Further, material damage also can occur due to natural influences, such as floods and storms. The transportation infrastructure remains vulnerable and can be damaged by floods, such as broken road fences and traffic signs (Diakakis et al. 2020). Damaged road fences and road signs were shown in Figs. 4a and 4b, respectively.
